**BAKER FLOODWATER RESERVOIR  
SITE 6A**

**NH 00477**

**PHASE I INSPECTION REPORT  
NATIONAL DAM INSPECTION PROGRAM**

**JUNE 1979**

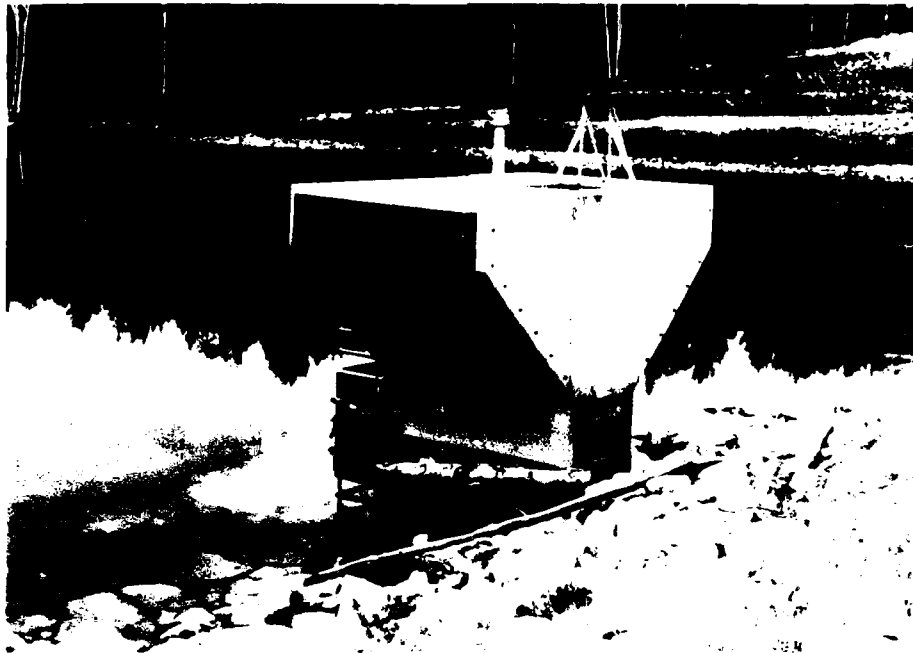
The concrete riser principal structure consists of three elements, an overflow control (low and high stages of spillway), a vertical transition and closed concrete discharge conduit. The riser structure is placed in the earth embankment. Visual inspection revealed that the riser structure appeared to be in good sound condition, Photos No. 9, 10 & 11.

PHOTO NO. 9 - View of right side of riser and principal spillway.

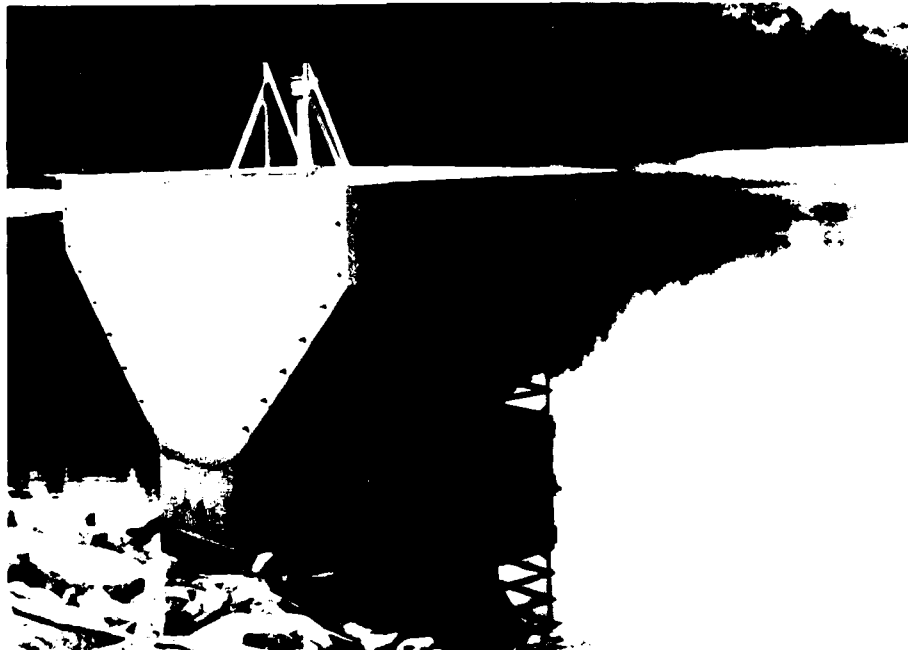
PHOTO NO. 10 - View of left side of riser and principal spillway.
